New York State Department of Transportation

Yellow Flag NB2358W007

BIN: 1065318

Feature Carried: 278I278IX2M23027

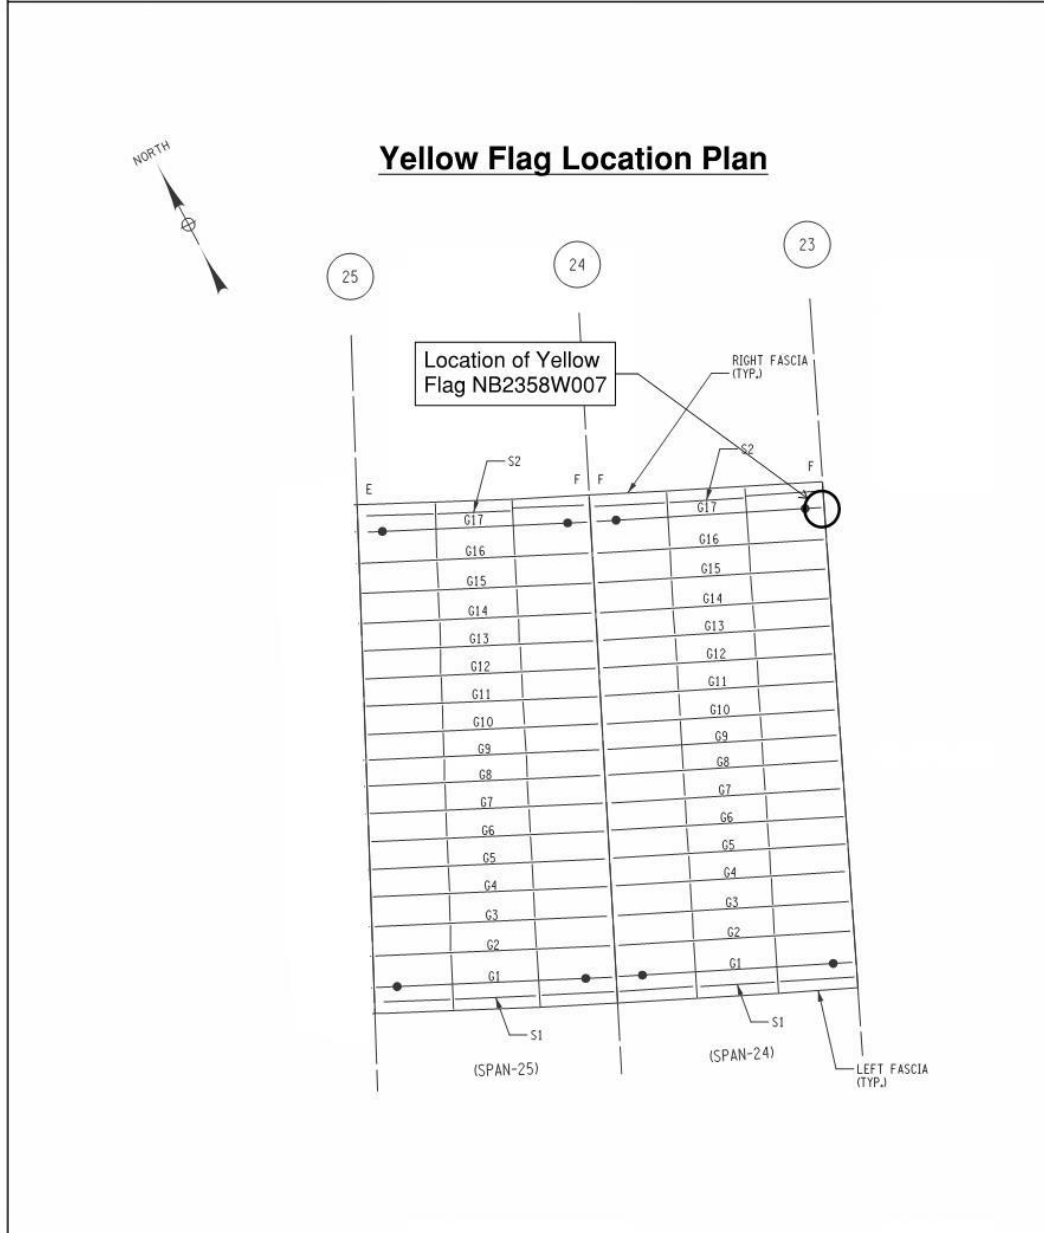
Flag PhotographsPhoto Number: **1**Photo Filename: **23_Flag Location Plan.jpg**Gowanus Expressway
2023 Biennial Inspection - Field SketchBIN: 1065318Team: AA/TSDate: 04/27/2023Span: 24Location: Girder G17 at Pier 23

Location: Span 24, Girder G17 at Pier 23 above the dirt area behind the fence along the 65th Street EB roadway between 4th and 5th Avenue.

**wsp****Attachment Description: Flag Location Plan**

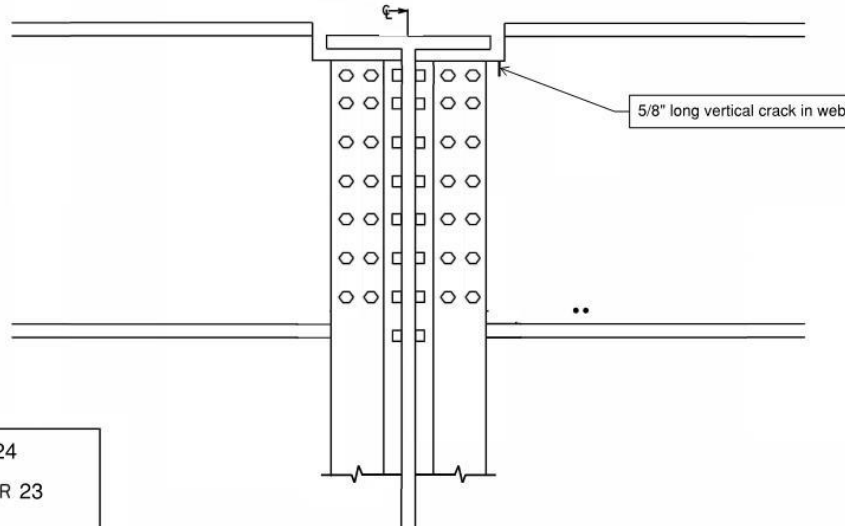
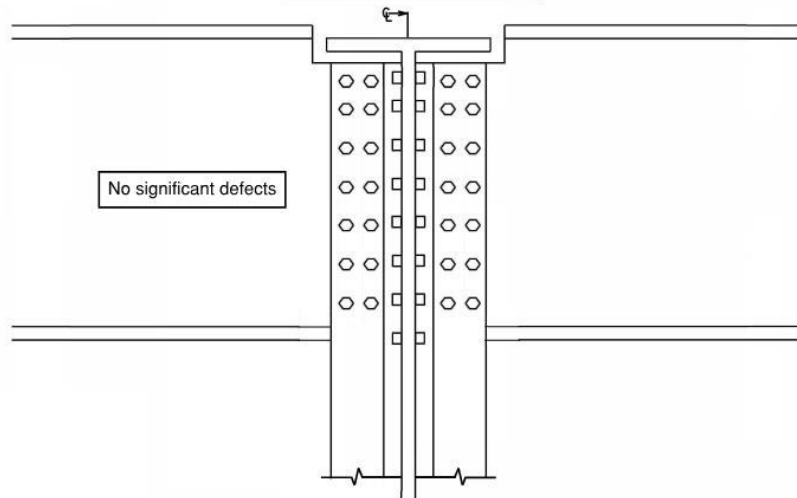
Photo Number: 2

Right Face of Girder G17

**Left Face of Girder G17**

Attachment Description: Flag Condition Sketch

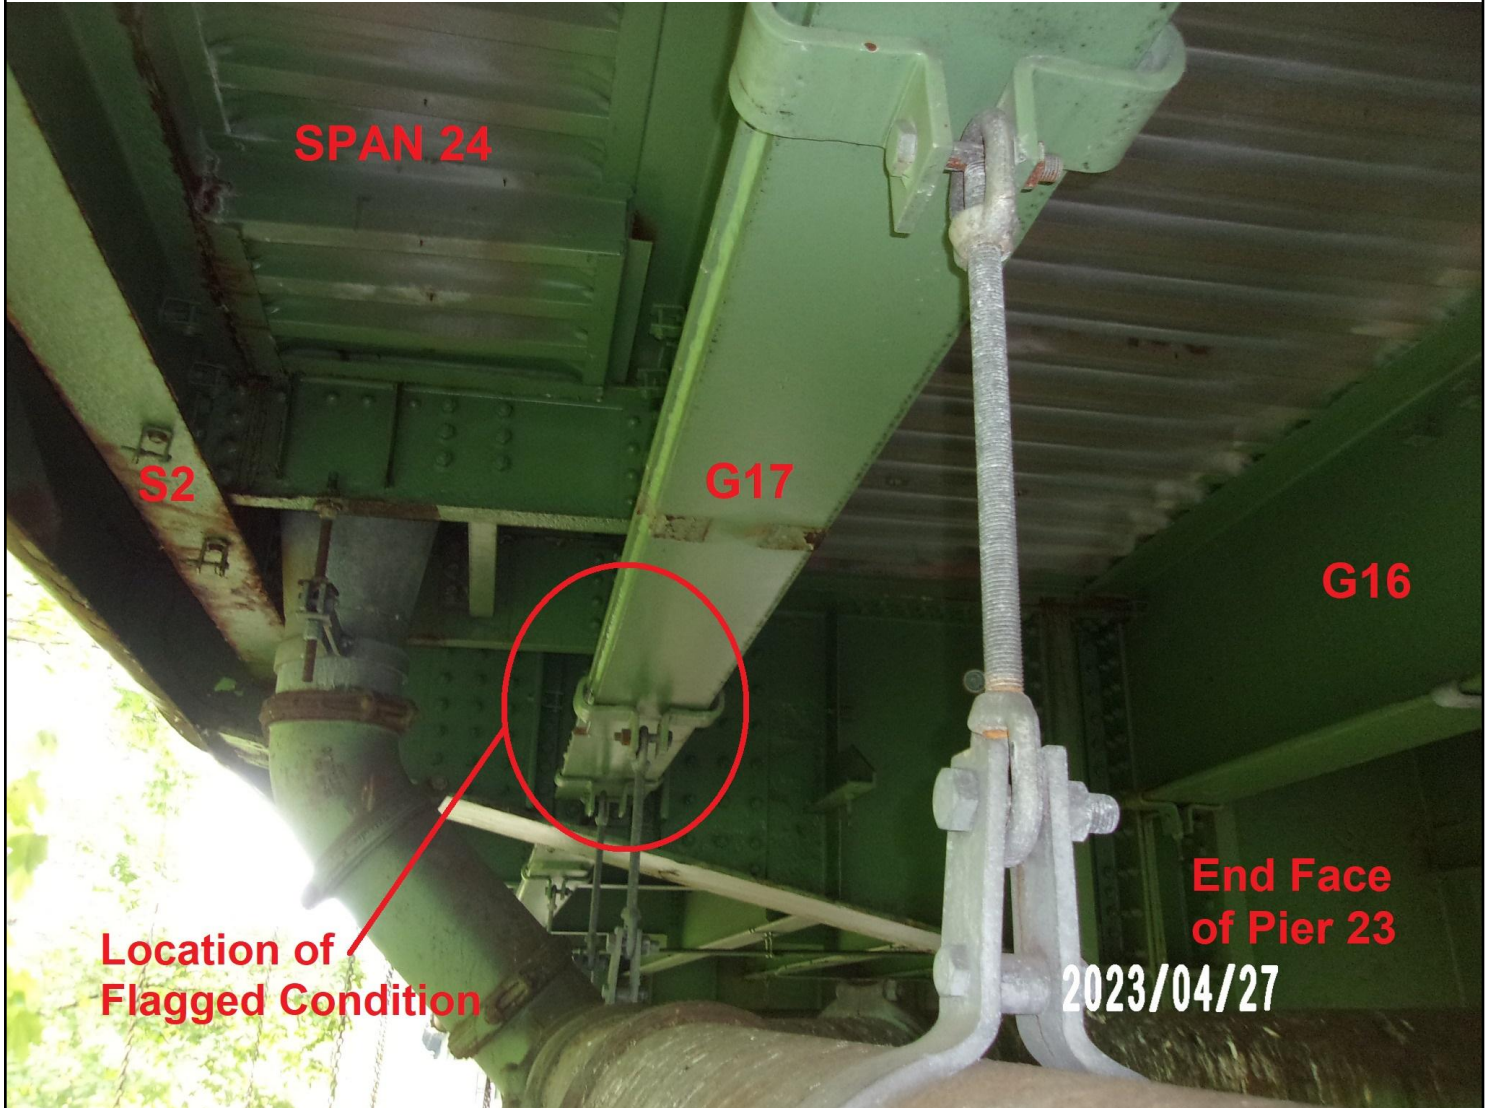
Photo Number: 3

Attachment Description: General view of the flagged condition at Girder G17 in Span 24 at Pier 23. Looking Begin.

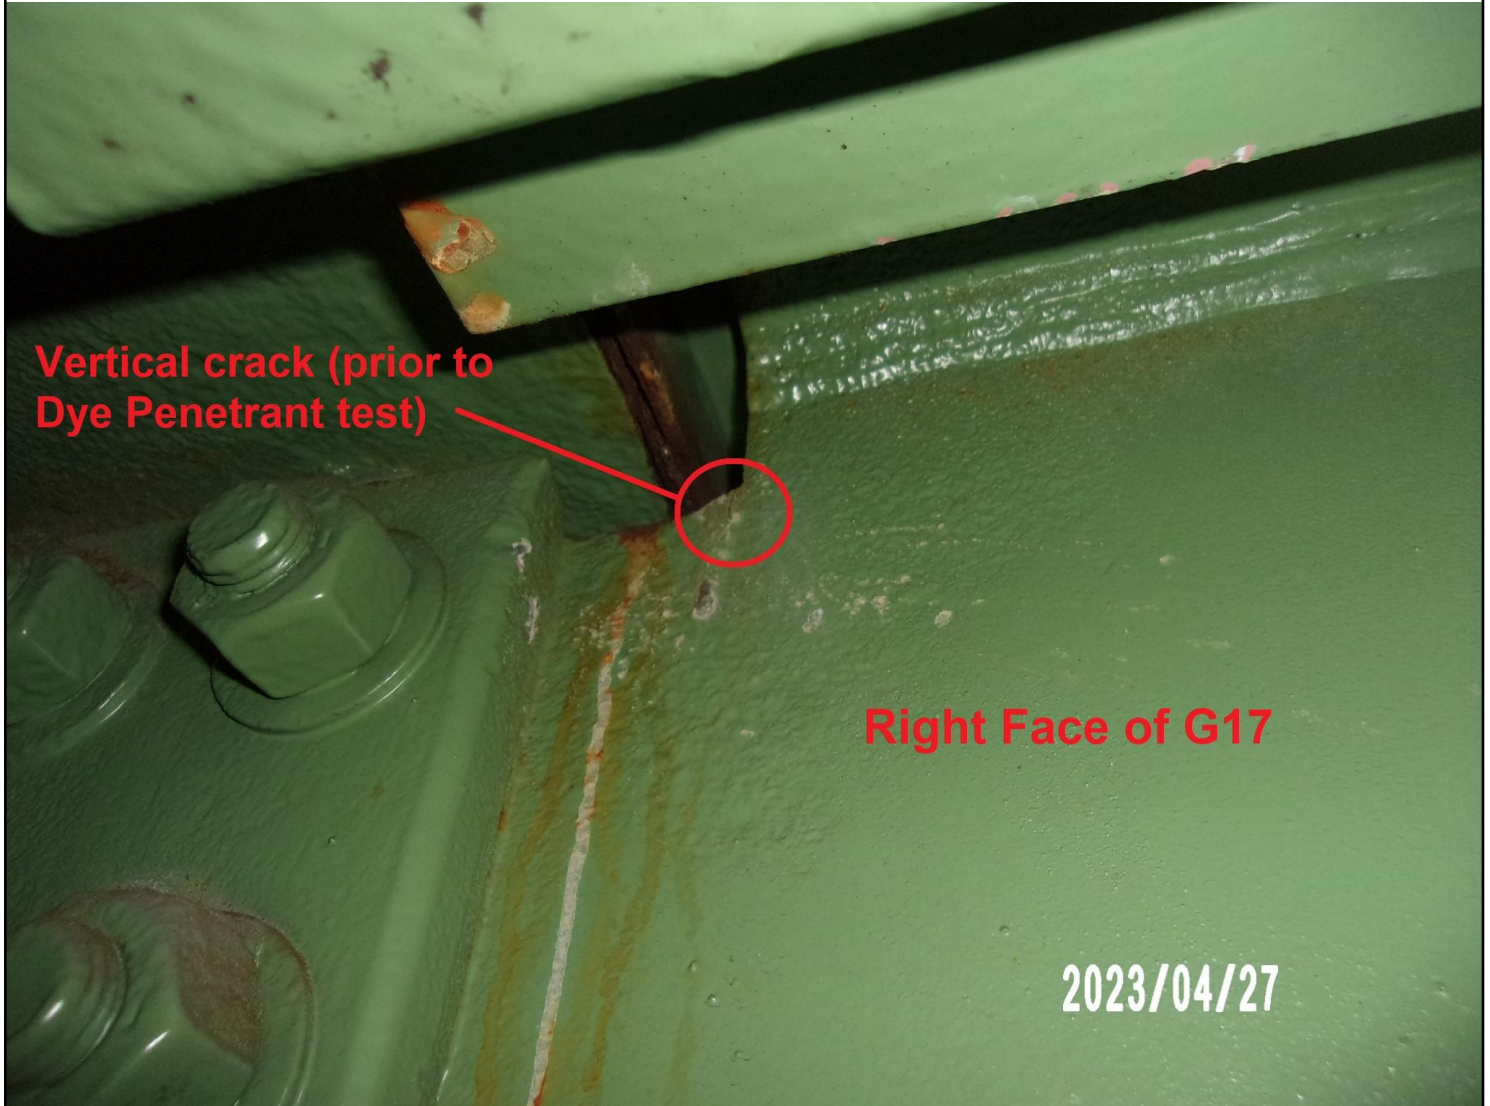
Photo Number: 4

The end of Girder G17 in Span 24 at Pier 23 exhibits 5/8" long vertical crack presently visible in the right face only (not full depth penetration of the web) starting at the top cope of the girder web (Photos #4 and #5). The remaining girder end exhibits no significant defects at the web and flanges (Photo #6). (refer to the Yellow Flag Condition Sketch Photo #2 for more details)

Attachment Description: The right face of Girder G17 in Span 24 at Pier 23. The girder end exhibits 5/8" long vertical crack presently visible in the right face only (not full depth penetration of the web) starting at the top cope of the girder web prior to the Dye Penetrant test (circled). Looking Left.

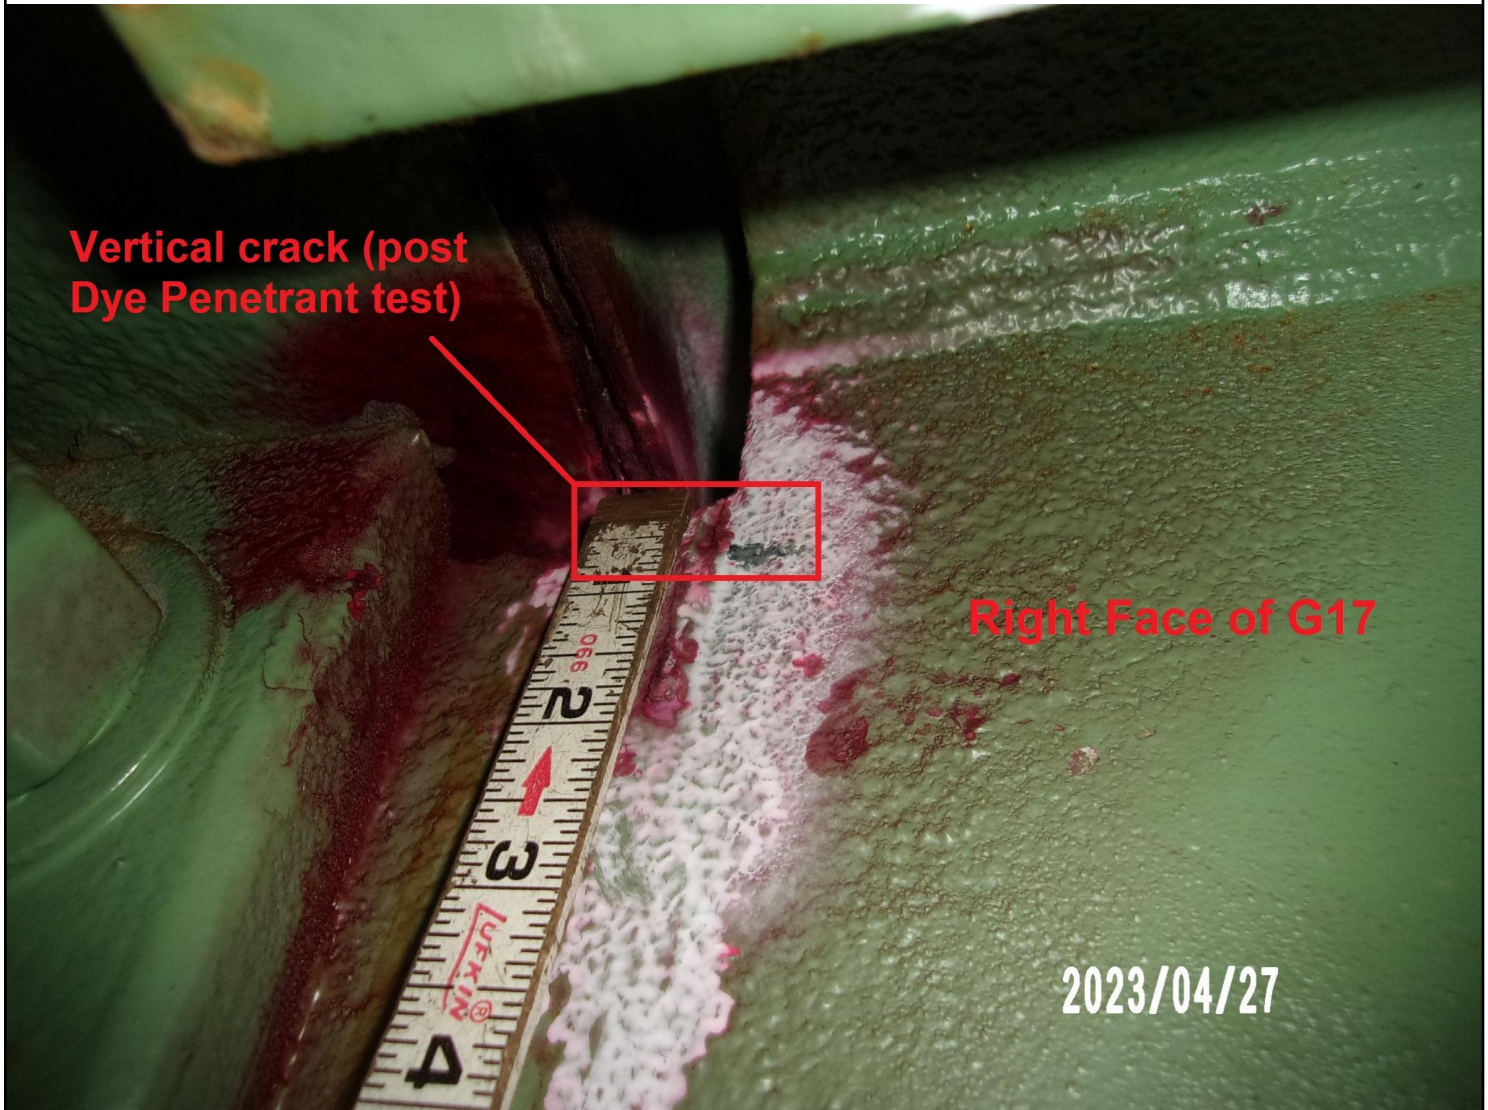
Photo Number: 5

Attachment Description: The right face of Girder G17 in Span 24 at Pier 23. The girder end exhibits 5/8" long vertical crack presently visible in the right face only (not full depth penetration of the web) starting at the top cope of the girder web post Dye Penetrant test (circled). Looking Left.

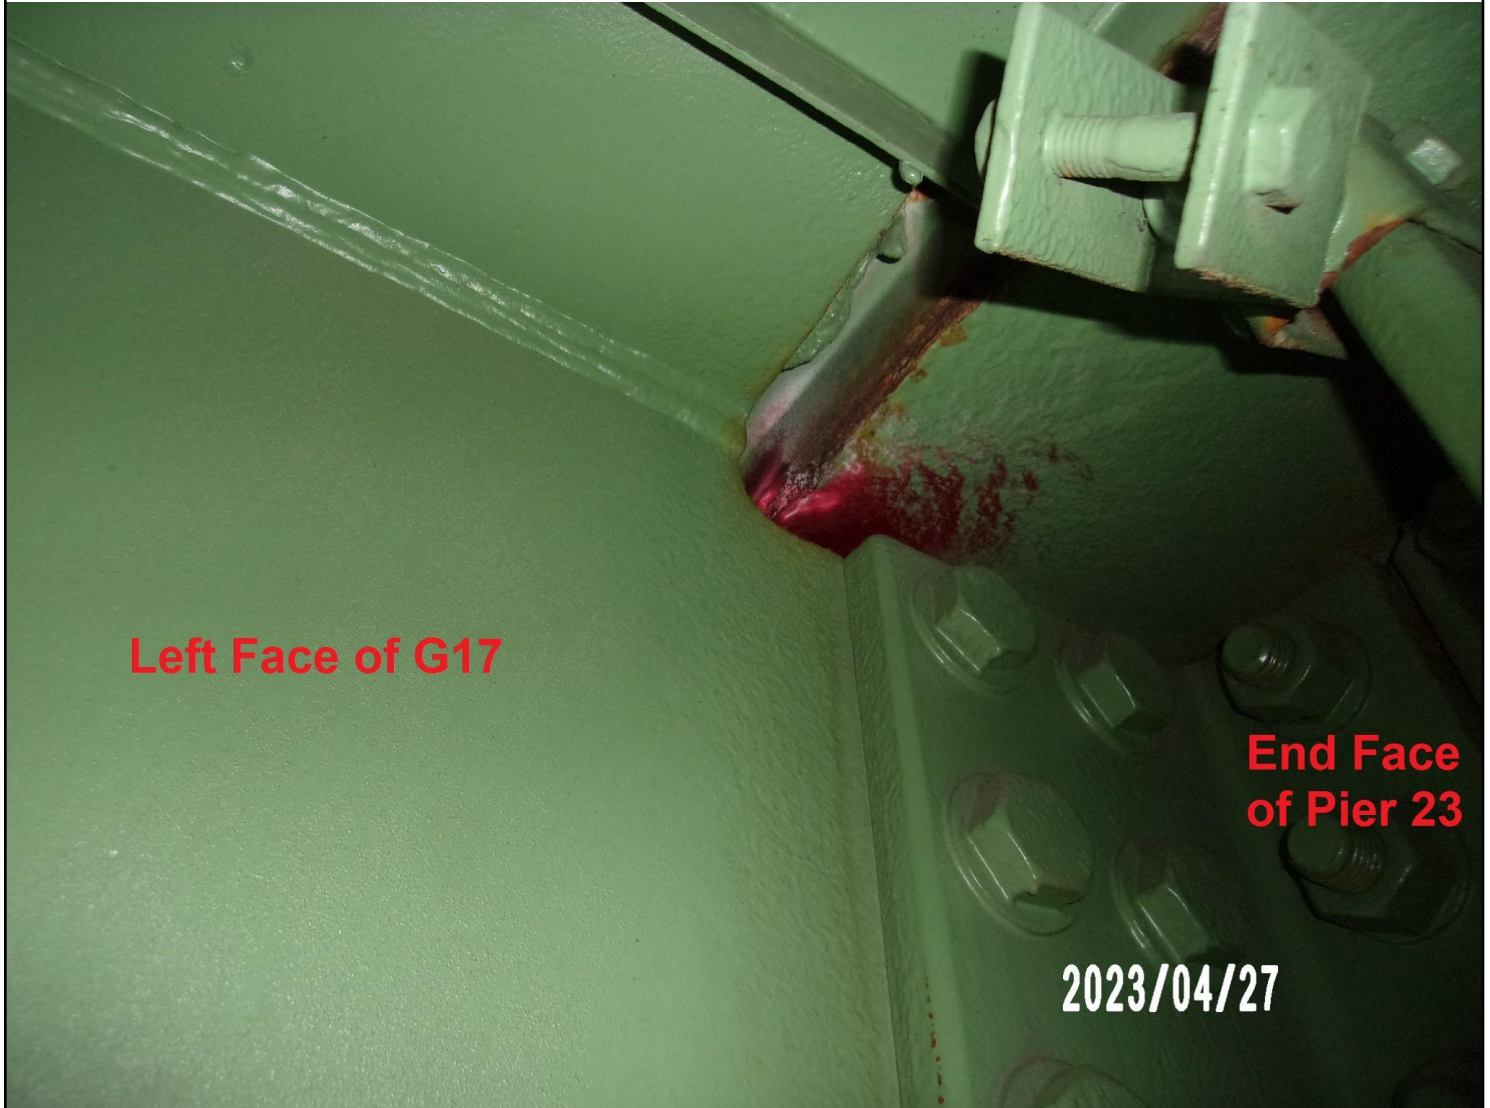
Photo Number: 6

Attachment Description: The left face of Girder G17 in Span 24 at Pier 23. The upper web of the girder at the top cope exhibits no significant defects. Looking Right.
